**SHORT-TERM MEASURES
TO MINIMIZE THE IMPACT OF
EXTREME CONTINGENCIES IN THE
BRAZILIAN POWER SYSTEM**

Xisto Vieira Filho

THE MARCH 11, 1999 BLACKOUT:

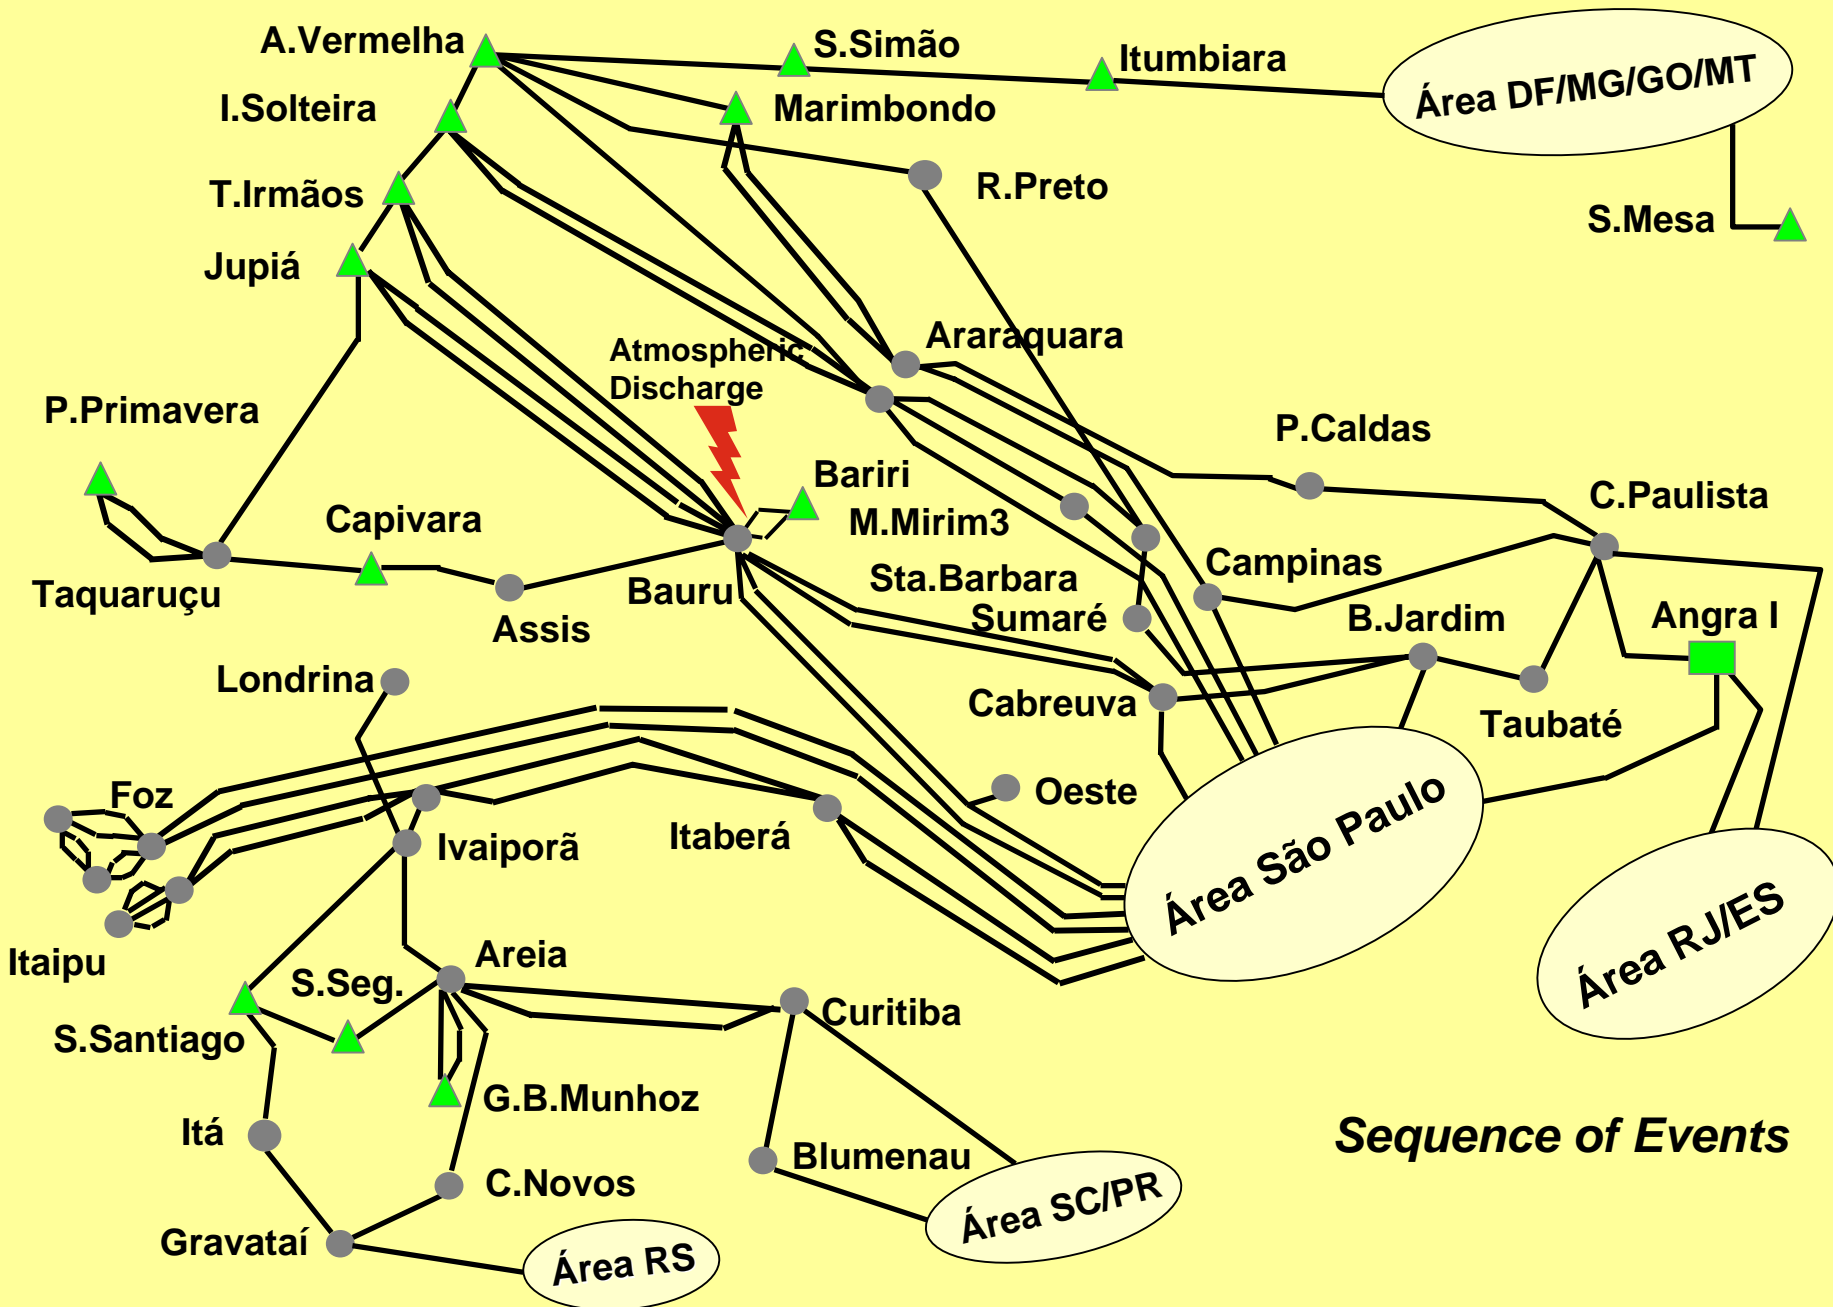
- Simultaneous loss of 5 lines (440 kV) following a fault at the Bauru substation.
- The tripping of a sixth 440 kV line (I. Solteira-Tres Irmãos) caused instability and collapse
- This tripping was due to 3rd. Zone relay misoperation.

Short-Circuit at Bauru Substation

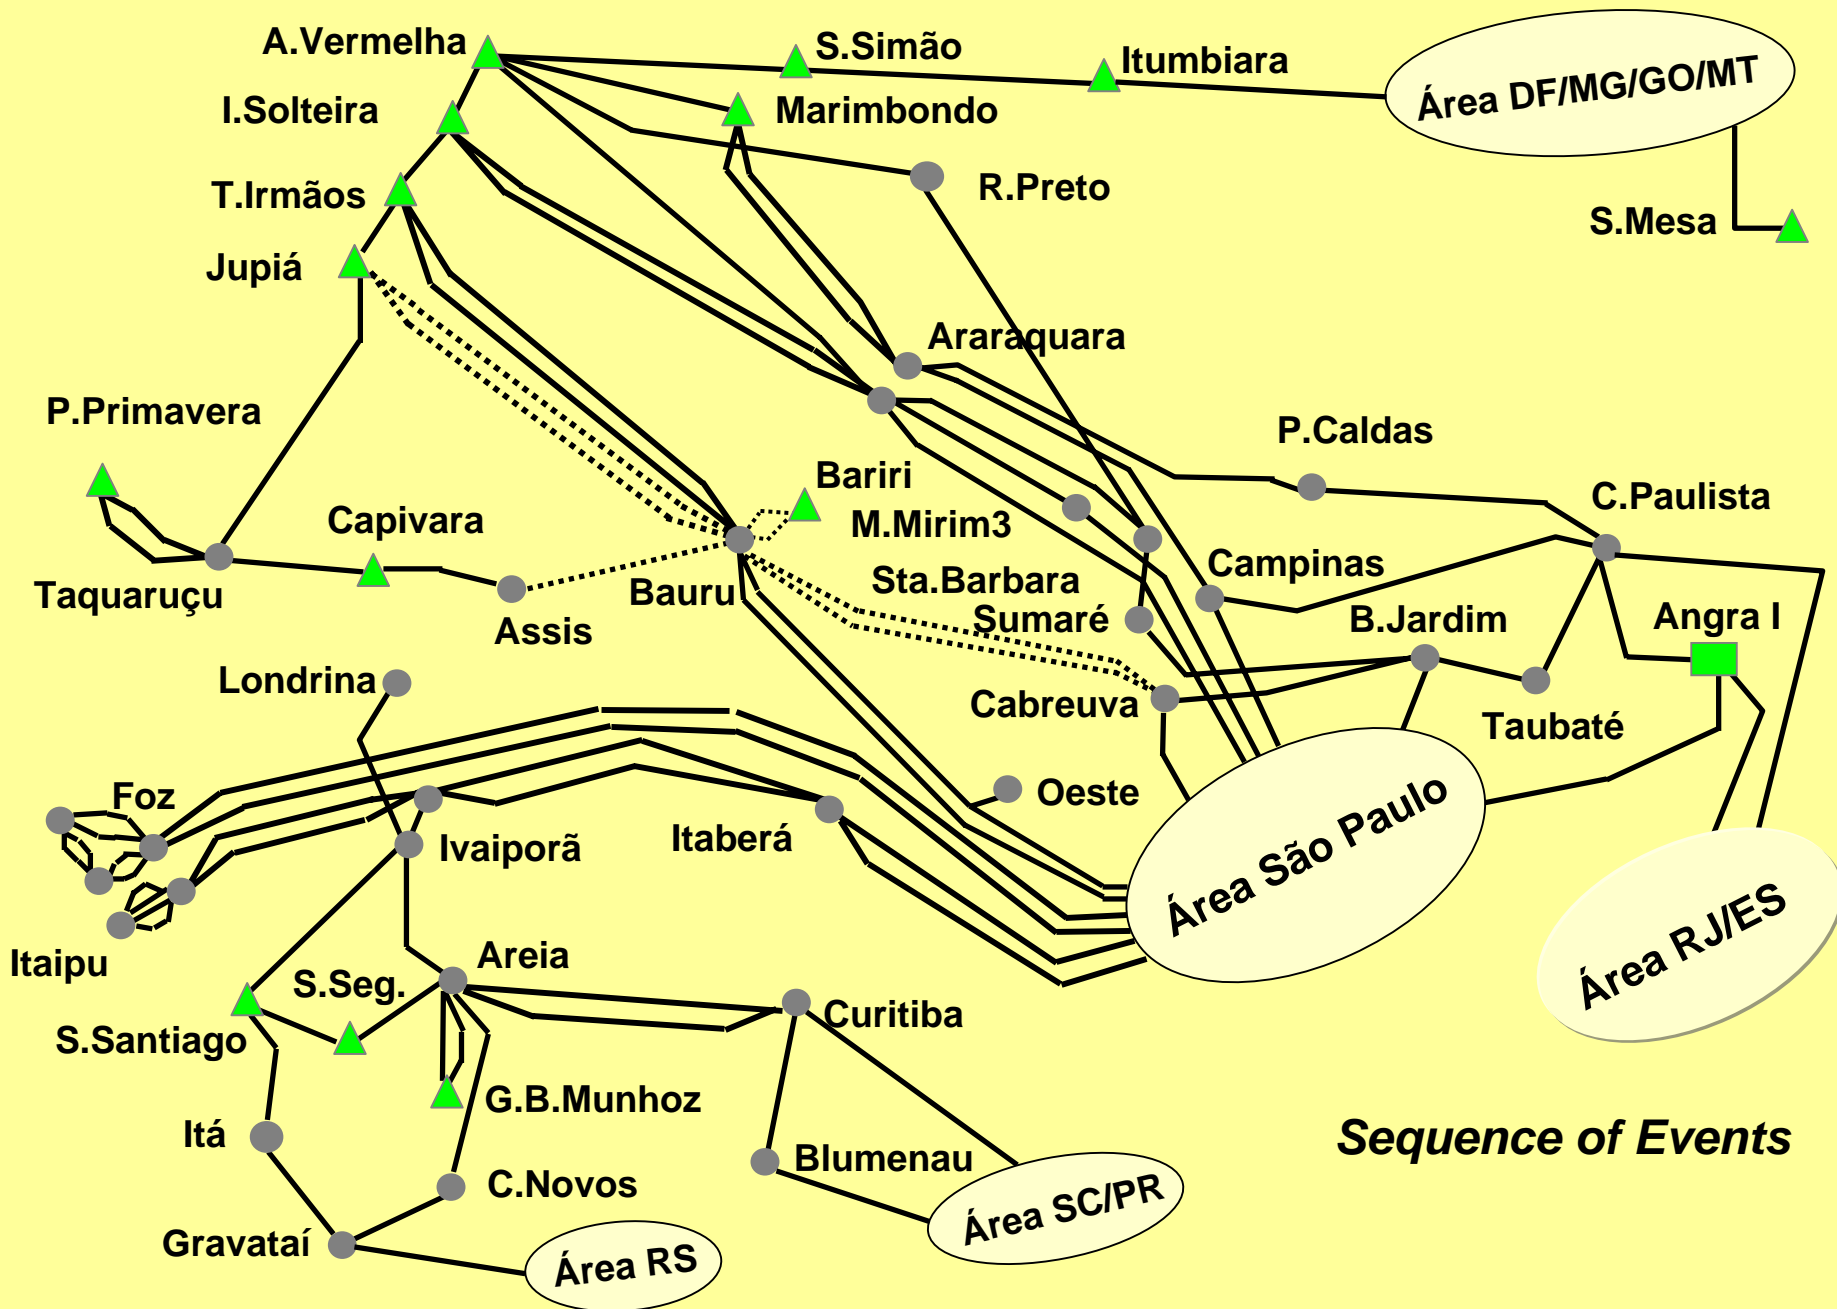
Loss of bus section and 5 lines (440 kV) at Bauru

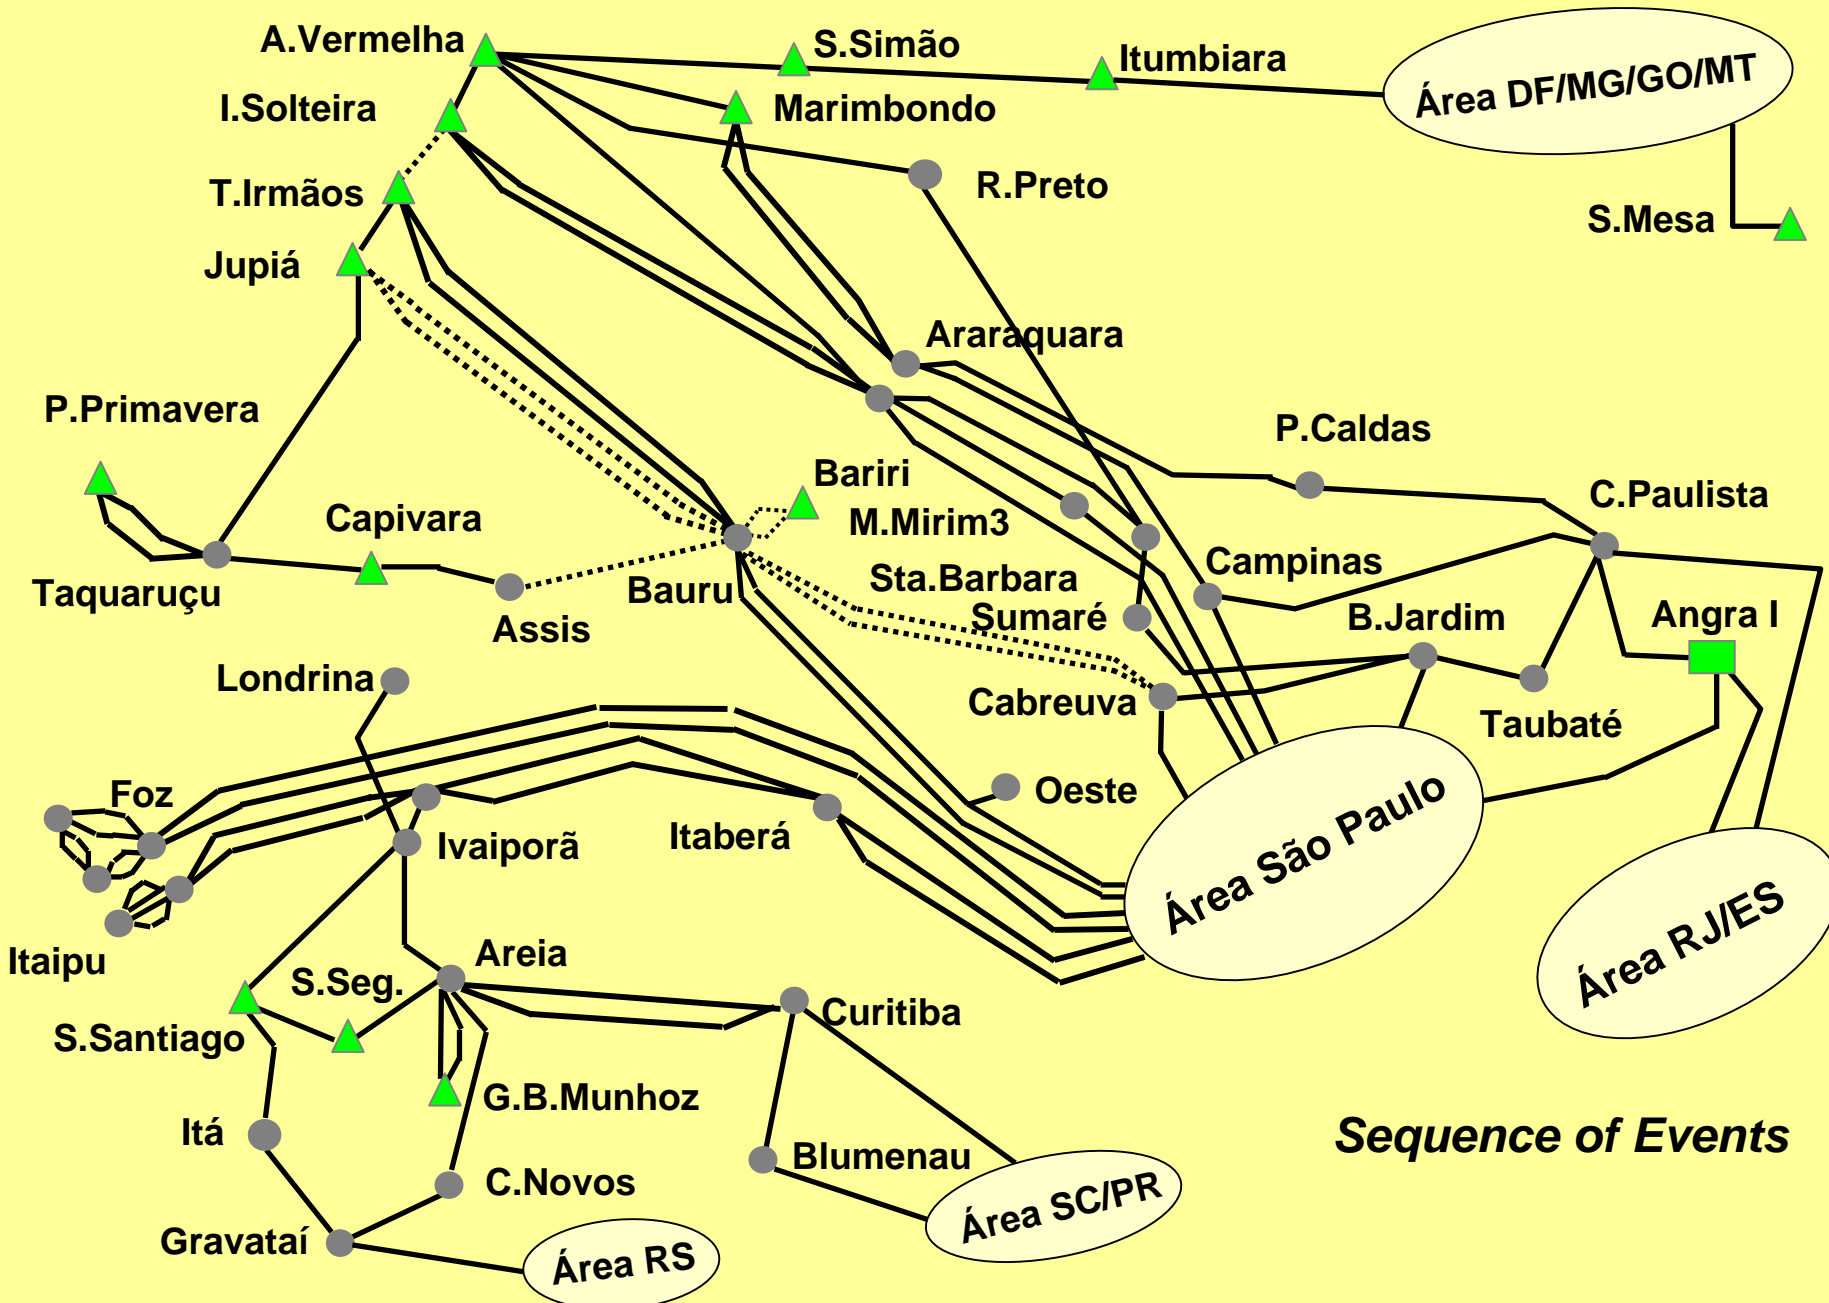
Tripping of Três Irmãos-Ilha Solteira 440 kV Line

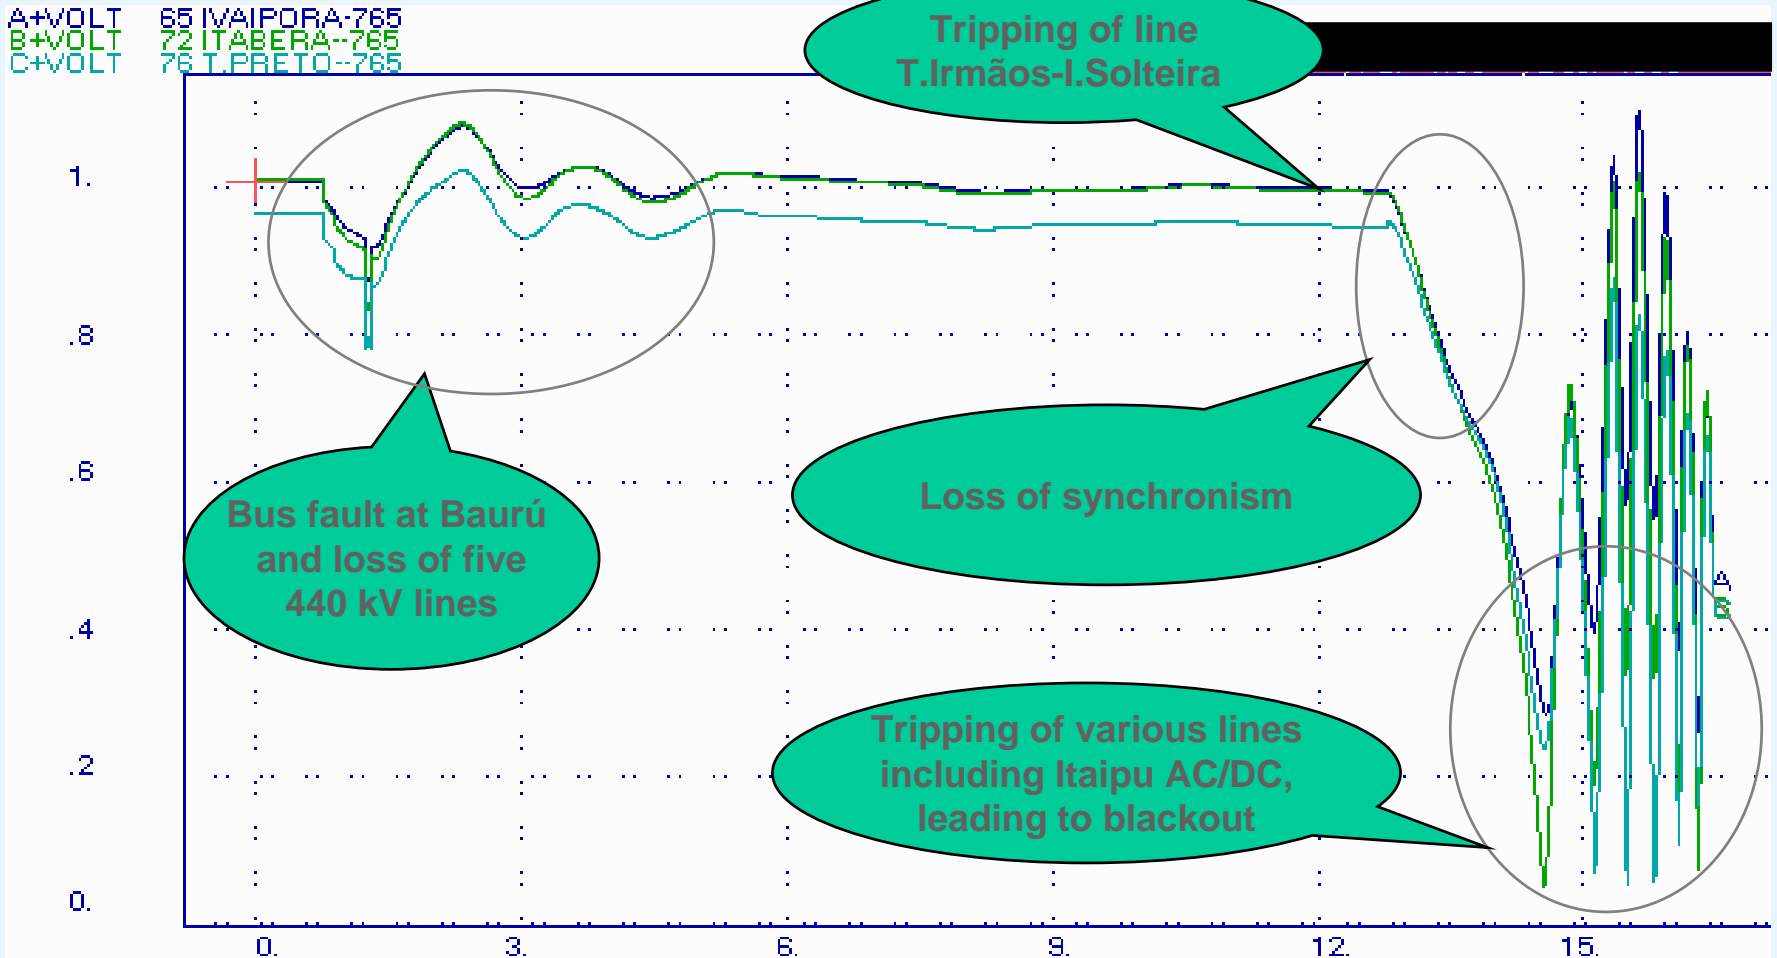
Chain Reaction Leading to Blackout

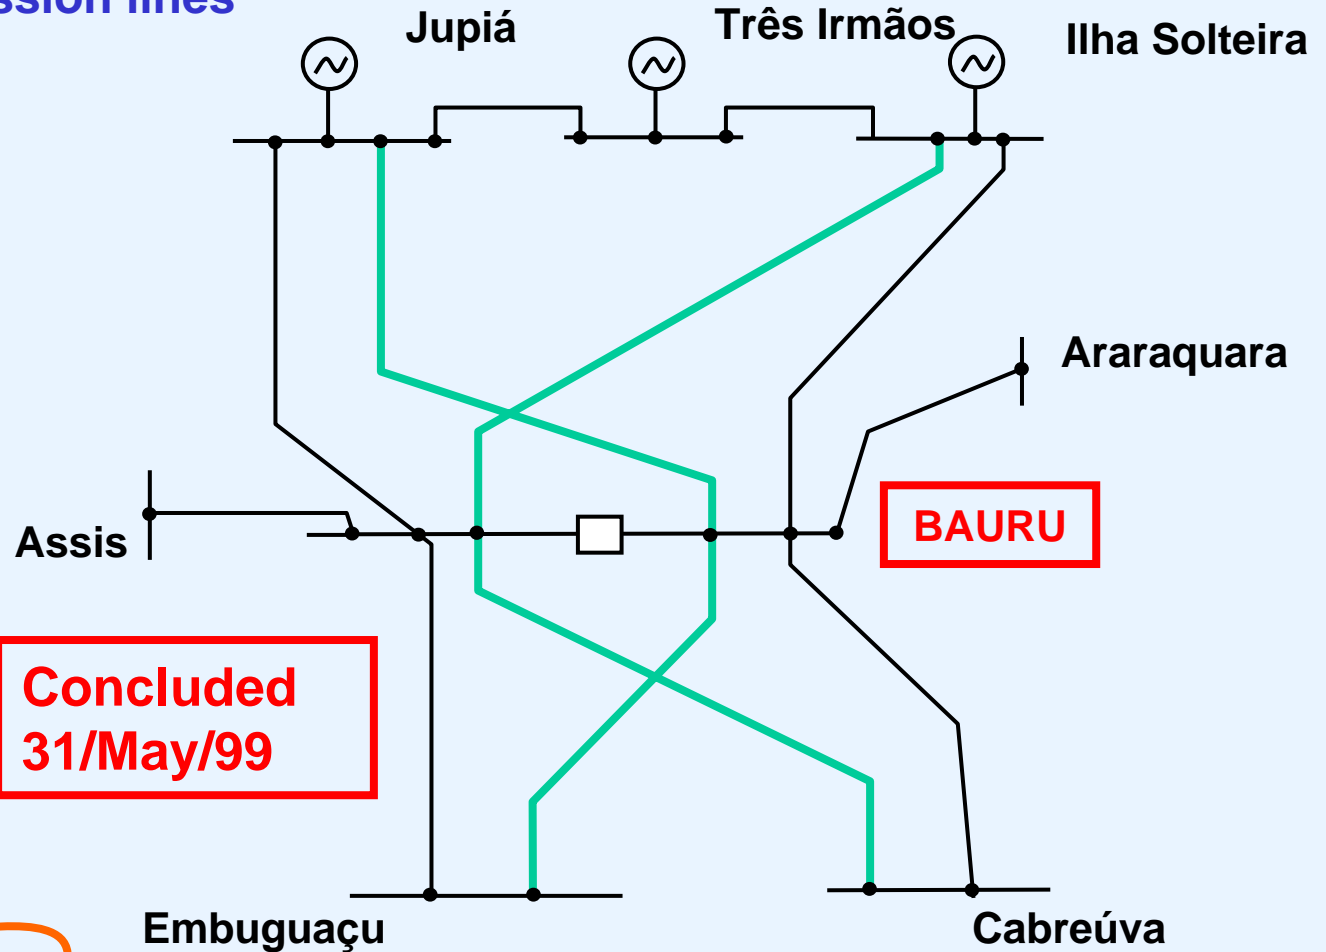
Fault in bus section of Bauru substation

- One circuit Jupiá - Bauru remains connected
- One circuit Bauru - Embuguaçu remains connected

1st. Stage: Transposition of incoming transmission lines

**Concluded
31/May/99**

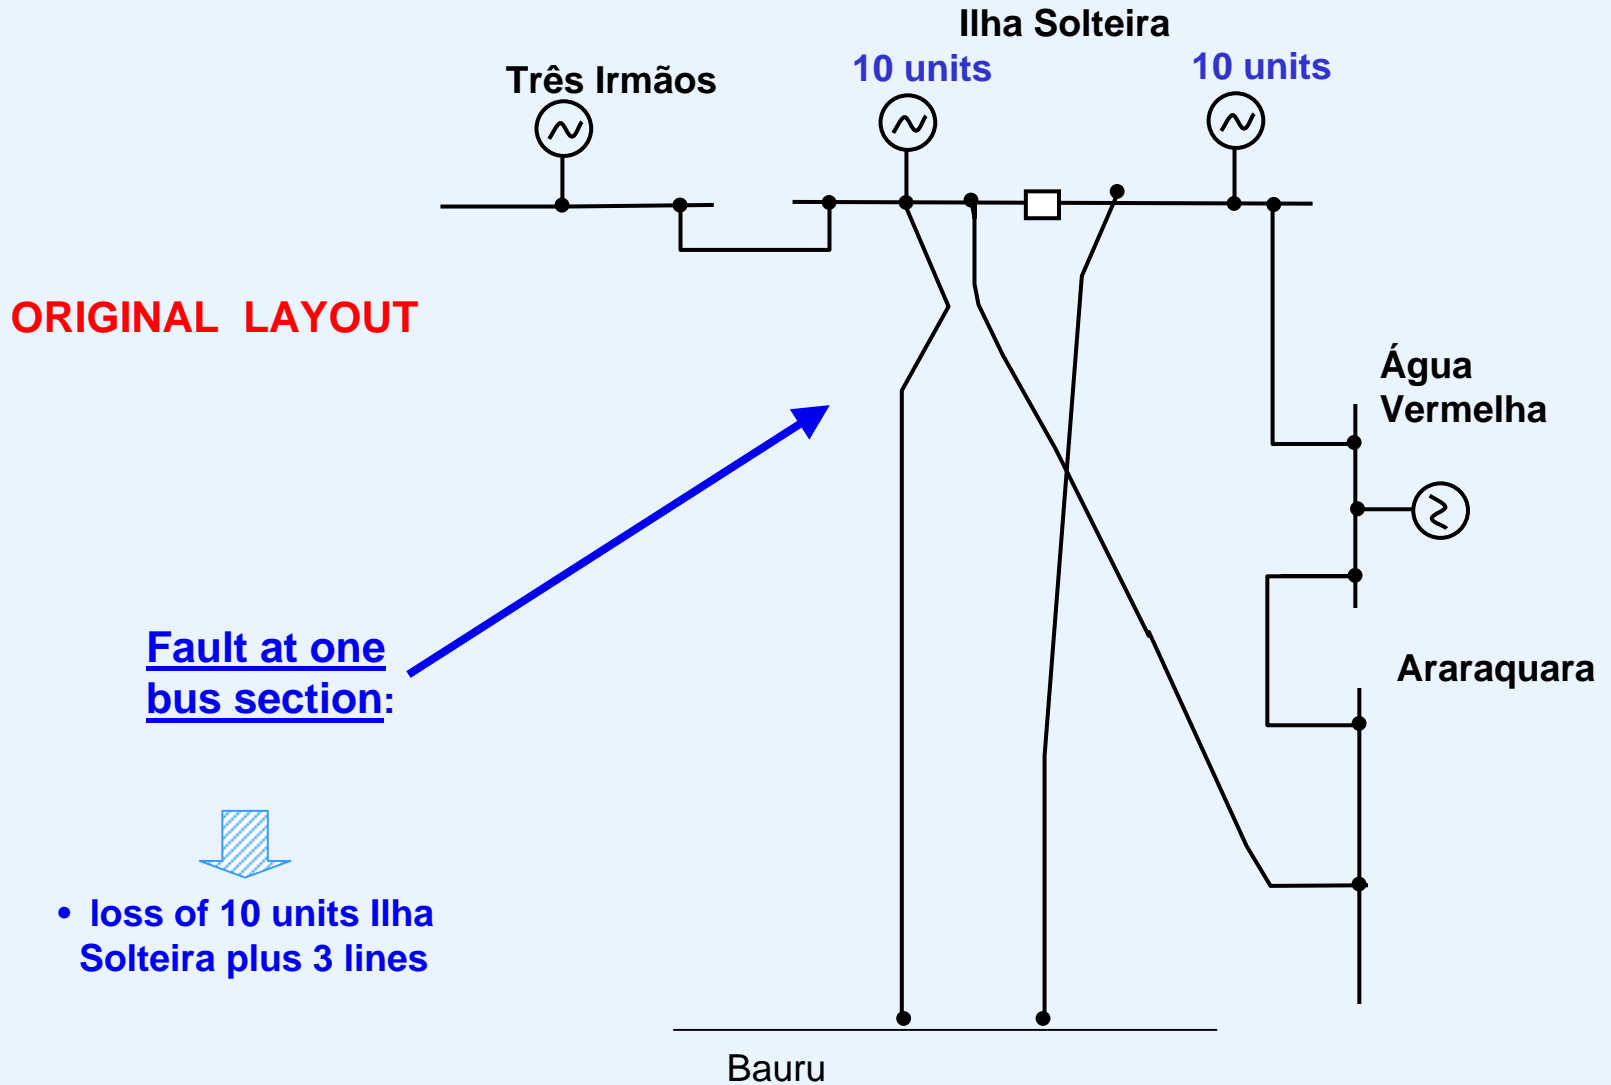
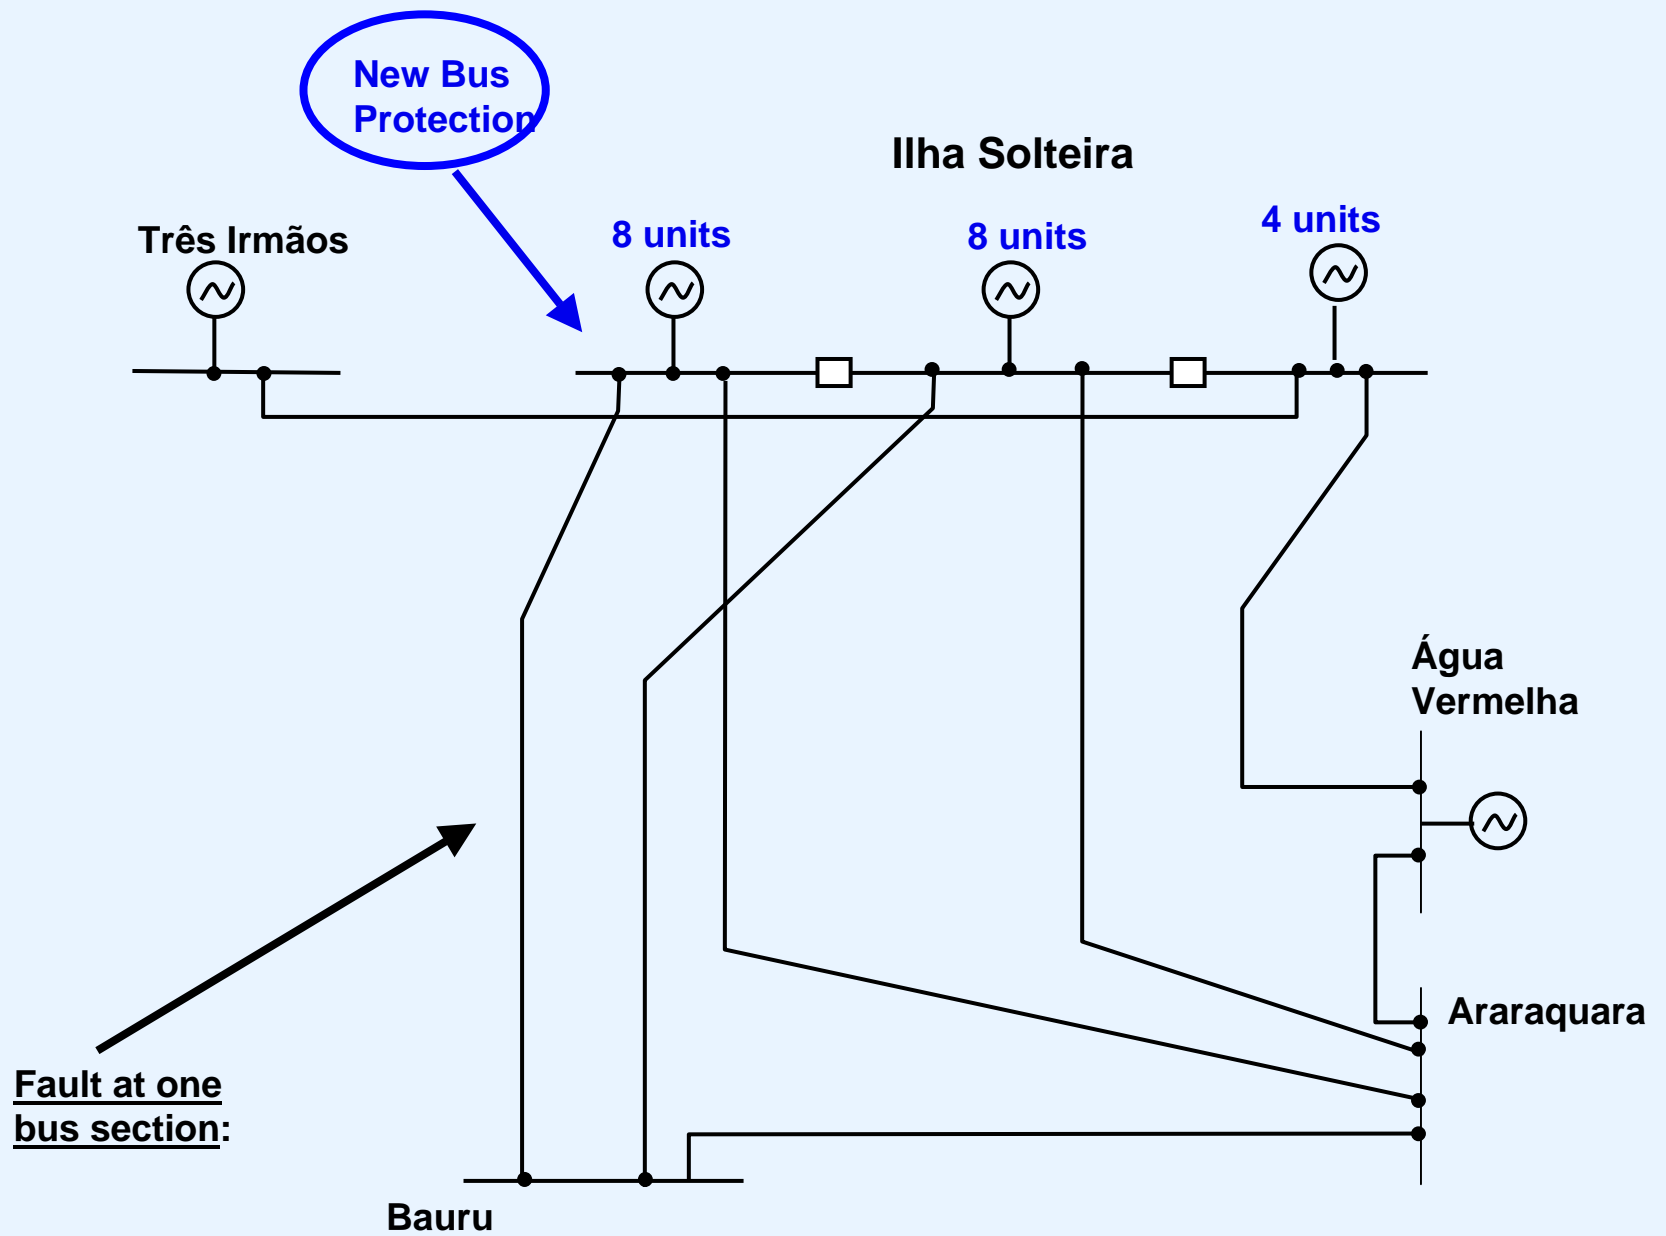
- loss of either 8 or 4 units and 2 transmission lines

Layout Changes at Ilha Solteira 440 kV Substation

**Concluded
31/Aug/99**
